OZARK NATIONAL LIFE BUILDING BALCONY

OWNER: OZARK NATIONAL LIFE INSURANCE COMPANY
ARCHITECT: INTERNATIONAL ARCHITECTS ATELIER
CATEGORY: CONSERVATION

UNIFIED GOVERNMENT FIRE STATION

OWNER: UNIFIED GOVERNMENT OF WYANDOTTE COUNTY + KANSAS CITY, KS
ARCHITECT: INTERNATIONAL ARCHITECTS ATELIER
CATEGORY: PRESERVATION PRACTICE

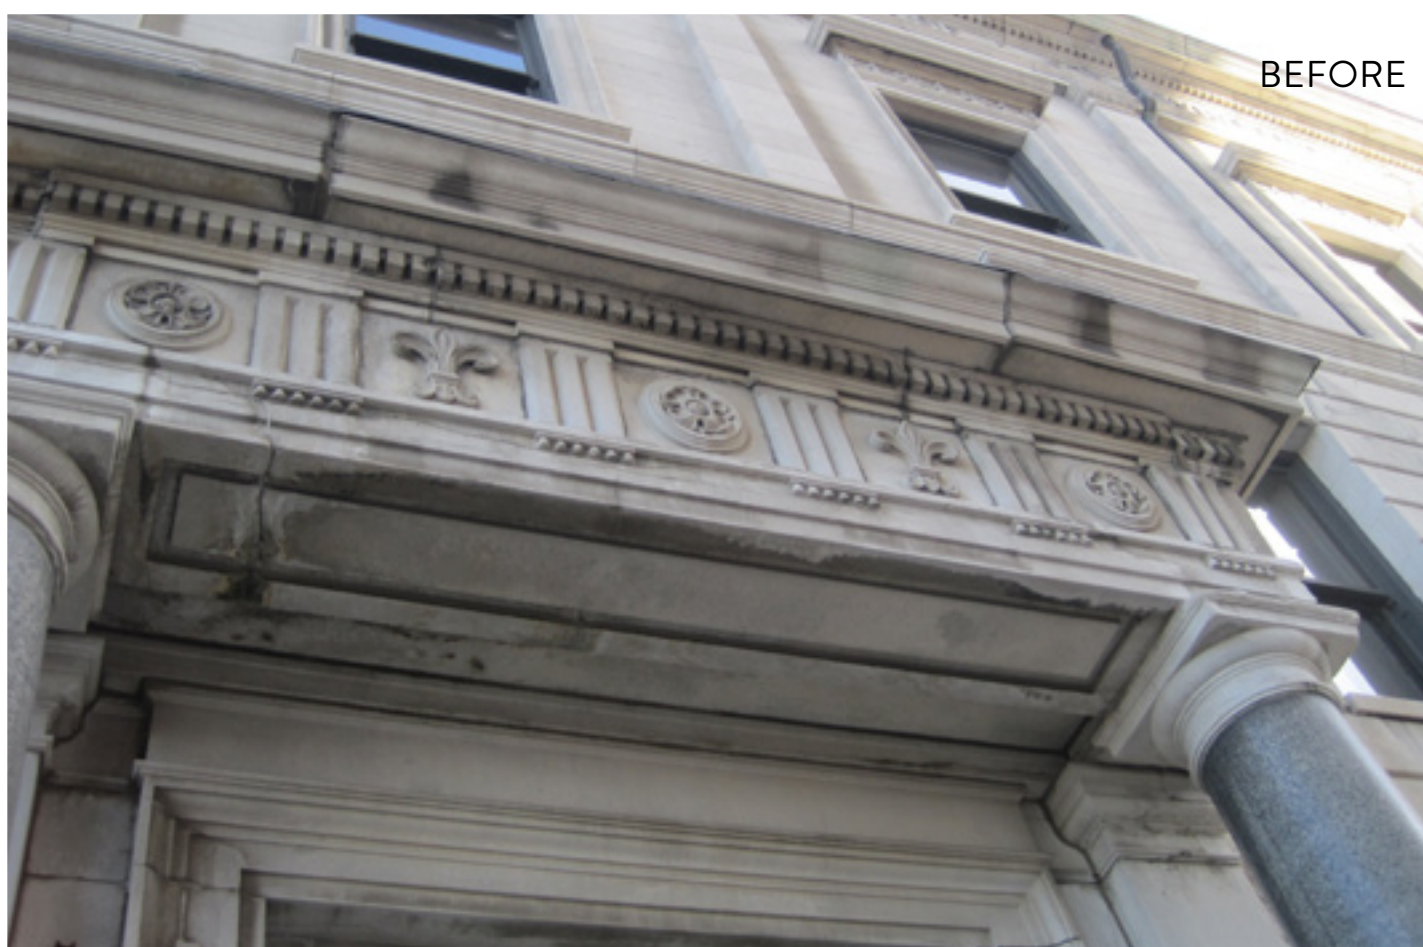
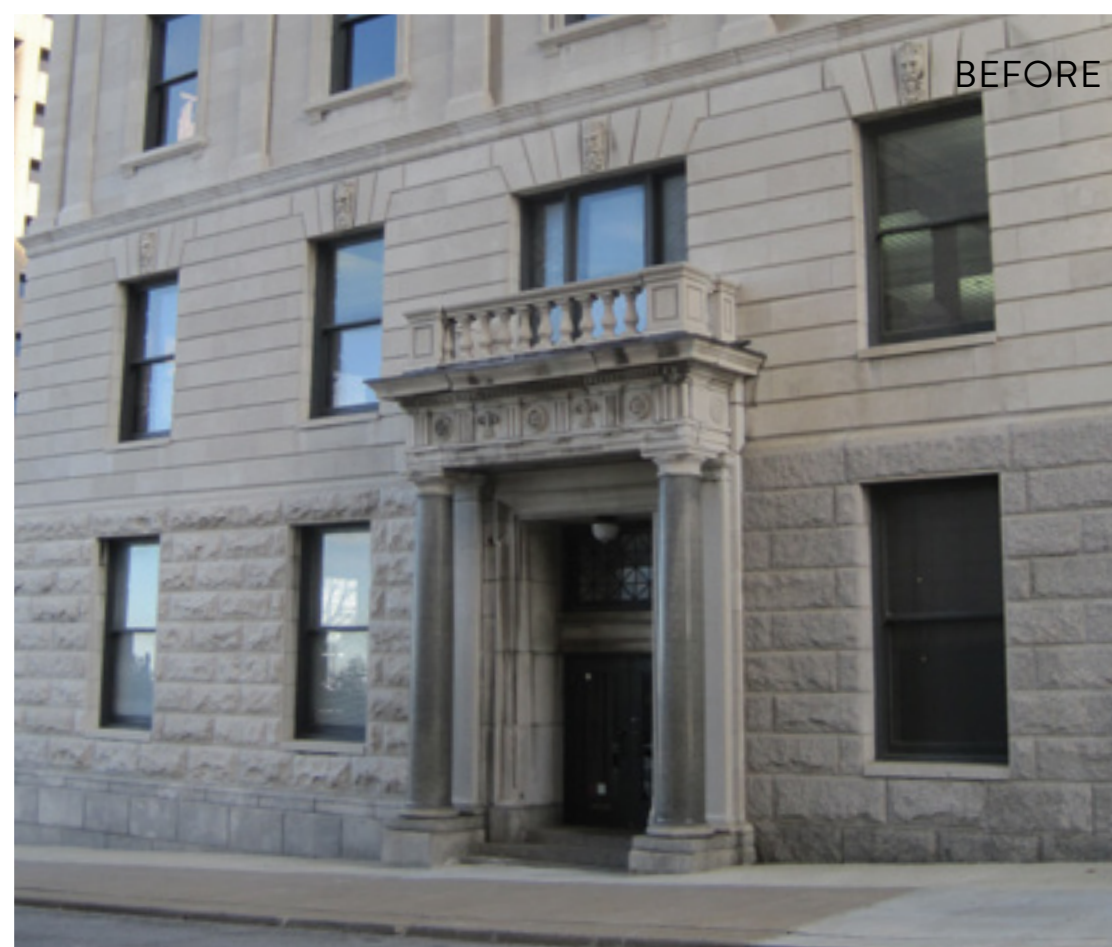
BEFORE

After investigating the Northwest masonry balcony, our team discovered significant cracking and shifting of the elaborately decorated stones, indicating severe structural damage. In order to replace the deteriorated steel supports and salvage the balcony and façade, all stones were catalogued and removed, allowing our team to explore the existing structure beneath. After replacing the steel components with new members, the entire balcony and baluster spindles were carefully restored and reset. The restoration work was performed with the intention of preserving key building elements, as they were originally envisioned, to ensure another century of life for this local landmark.

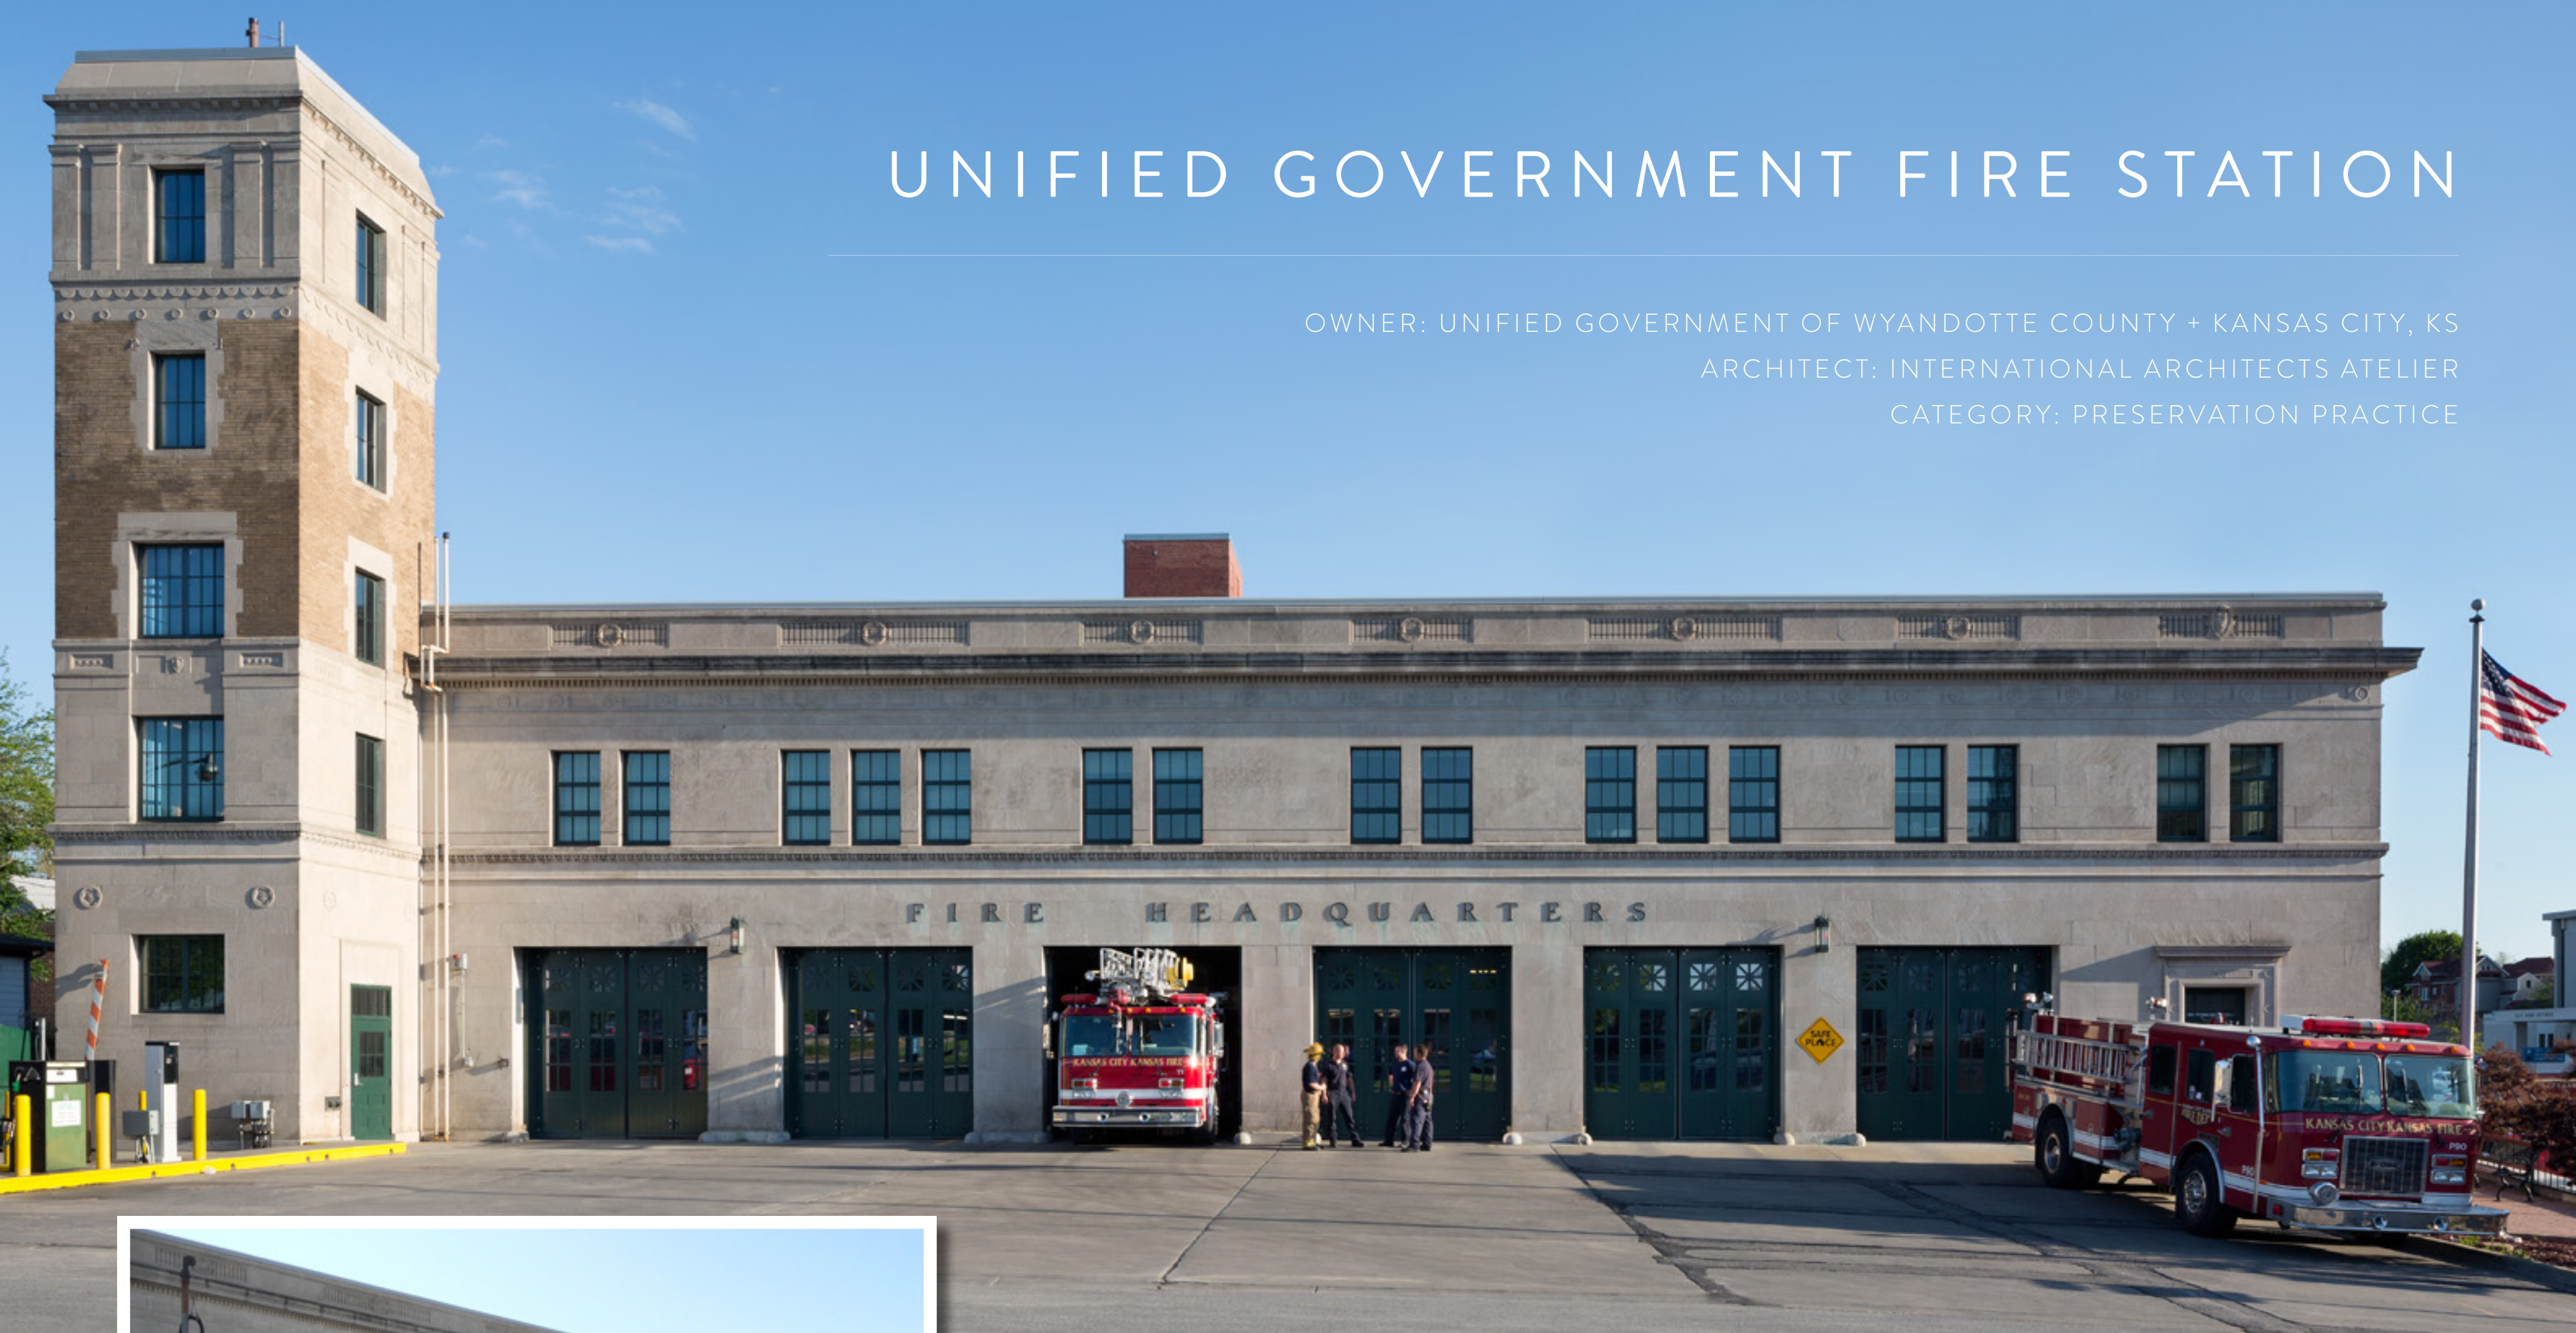
Top: WYCO + KCK Fire Headquarters, Spring 2015 following restorations. Top Left: By 2000, most of the historical elements that remained were deteriorating. Those that had been replaced, like the doors and windows seen in this image, were not in keeping with the original aesthetic of Keyser's design. Middle Left: A 1937 image of the fire headquarters and several firefighters posing with their new American LaFrance fire equipment. Bottom Left: 1930 image of a firefighter in front of one of the four-fold doors.

IAA was commissioned to restore Keyser's design, and repair or replace all doors and windows. Our team recognized the significance, not only in restoring the structure, but also in preserving its original character. However, this presented unique challenges, considering the fire station is still fully functional today. Nevertheless, it was a situation our team was eager to take on.

Of the nearly 85 window openings, virtually all still held the original steel frame windows and single pane glass. Each were replaced with aluminum historic replica ones to match the originals. The six existing overhead doors (top left), installed decades after the building was completed and clashing with Keyser's design, were replaced. Through research and historic images, our team discovered that the original doors, seen in the two bottom images to the left, were of a four-fold design. Luckily, we were able to replicate them, but in a modernized, electric and highly-functional version. Ultimately, each repair and update was made with this primary objective in mind: maintaining the historic integrity of Keyser's original design in order to ensure authenticity and longevity for years to come.
